# An experimental study of the effects of engine torque variation on the power spectrum of a healthy and a cracked helicopter transmission

by  
Prof. Panagiotis Sparis and Prof. George Vachtsevanos  
Democritus Univ. of Thrace Electrical Engineering Dept.  
Georgia Tech Visiting Scholar Georgia Tech

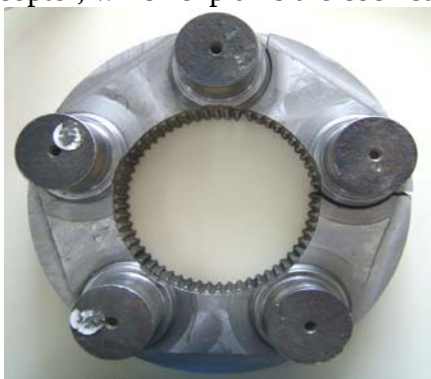
Fig. 3. Carrier Plate with five cracked posts.

progress. Fig.3 illustrates the most advanced crack in post#1. This plate was made of St50, a relatively less brittle material than the high tech titanium plate in the helicopter, which explains the coexistence of five advanced cracks.

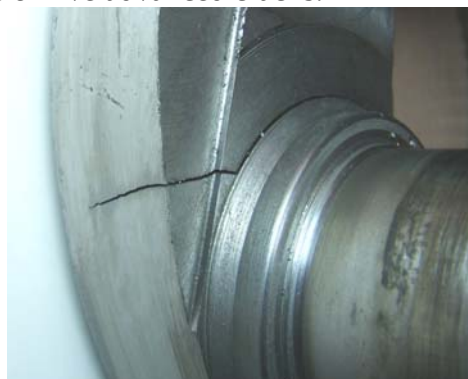
Fig. 4. Carrier plate #1 post crack
