GARAGE STRUCTURE VIBRATION TRANSMISSION TO HUMAN OCCUPIED SPACES

Jack B. Evans*¹

¹**JEAcoustics** / Engineered Vibration Acoustic & Noise Solutions
1705 West Koenig Lane, Austin, Texas 78756, USA
Evans@JEAcoustics.com

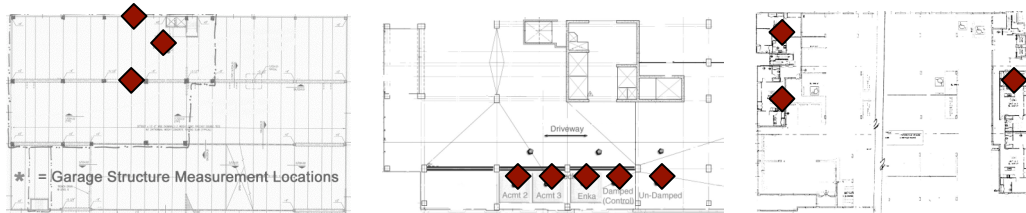
Figure 0,^{1,2,3} A, B & C– Plans: Garage 1 (left), Garage 2 (center) and Garage 3(right)

Garage 1 – Long span double tee-beam

An office structure was proposed to be built on top of an existing concrete parking structure. Steel column extensions would support a steel floor structure above. The existing structure has 11 m (36') long inverted tee beam girders supporting 17.1 m (56'-3") long double tee beams. The double tees are 3.65 m (12') wide and 750 mm (30") deep, with a continuous 70 mm (2.75") lightweight concrete topping on the double tees for total slab thickness ≈ 175 mm (7"). Apparent structural resonance from heel drop impact is 2.5 Hz with a prominent 5 Hz harmonic. The driveway occupies the mid-span of the beams (parallel to girders), with parking spaces on both ends of the tee-beam spans. Measurements were taken on tee beam deck at mid span, near girders and on a concrete column cap that steel extension columns will bear on.

An existing concrete parking structure was used as a proxy, to represent a proposed concrete structure, where the garage driveway and parking slab is to be extended laterally to accommodate residential condominiums on the same slab. The existing structure has columns spaced 8.83 m (29') parallel to the driveway. The driveway bay is 8.6 m (28'-3") wide, and the adjacent parking bay is 4.75 m (15'-7") wide. The post-tensioned (PT) flat slab is 190 mm (7.5") thick for driveway and parking. Apparent structural resonance (measured as response to heel drop) is 9.2 Hz on the driveway "source" and 13 Hz on the parking or "receiver" slab. The driveway lane and parking spaces are on separate bays, separated by columns. Measurements were taken on the driveway bay and in the immediately adjacent parking bay. Although the proposed future facility would have a parking bay between driveway and residential floors, the existing adjacent parking bay was used as a proxy for the future residential floor (on the next bay beyond parking). Concrete masonry units (CMU) were stacked along the column line to provide mass damping on the structure (to simulate) demising partitions. Simultaneous measurements were made on driveway (source) and residential proxy (receiver). Decoupled "receiver" floors were created by installing slabs of 25 mm (1") to 38 mm (1.5") gypcrete on 6-20 mm (1/4"-3/4") thickness nylon filament resilient underlayment. The decoupled slab surface responses were measured for comparison with no decoupled surface.

A concrete parking structure was constructed to accommodate wood frame residential apartments above, but also had two apartments each on the east and west outer bays. The garage has one column-supported level above a slab-on-grade level plus one upper slab above parking that the wood-framed apartments are constructed on. The column-supported concrete parking level is extended laterally one additional bay to accommodate two apartments on each end of the building (four total). The post-tensioned (PT) flat slab is 250 mm (10") thick on the east end, with column spacing 9.75 m (32'10") parallel to driveway by 11.57 m (38') driveway bay width and 4.87 m (16') adjacent apartment bay width. Slab thickness is 215 mm (8.5") with irregularly spaced columns. Apparent structural resonance (measured as response to heel drop) is 11 Hz for the 250 mm slab and 12.5 Hz for the 215 mm thick slab.

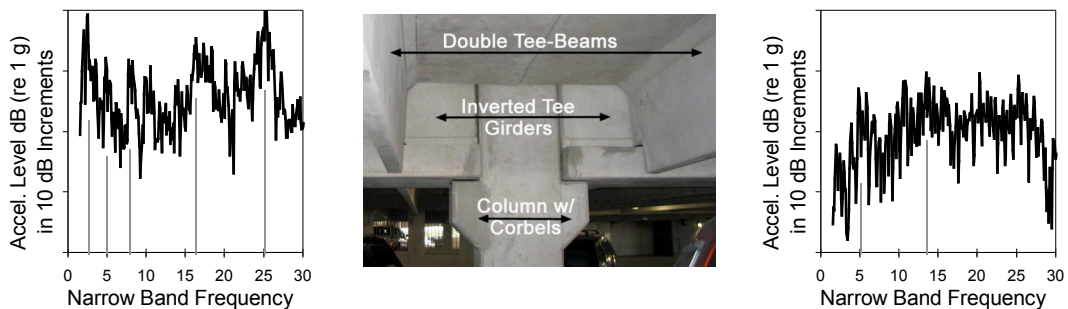
Figure 1, A & B¹– Apparent Resonant Frequencies: (A) Tee-beam deck and (B) Girder beam

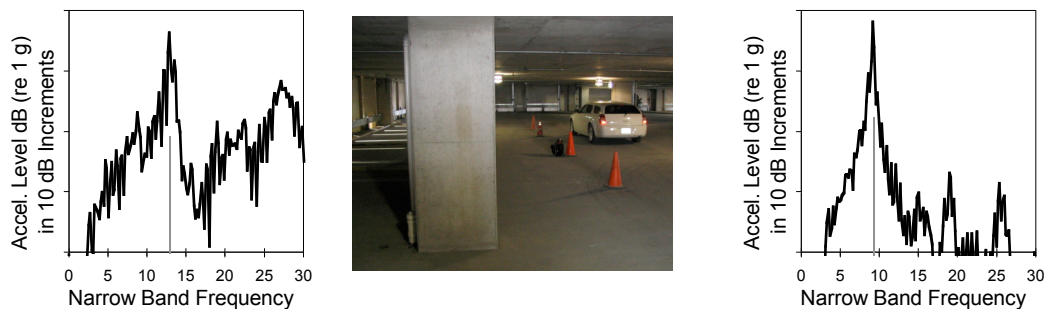
Figure 2, A & B² – Apparent Resonant Frequencies: (A) Parking bay and (B) Driveway bay

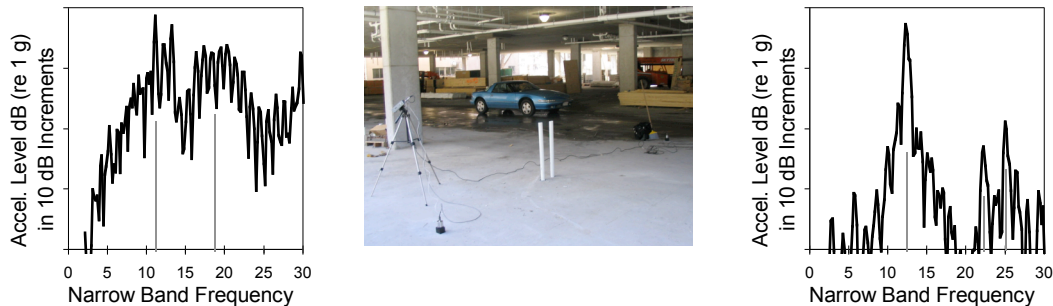
Figure 3, A & B³ – Apparent Resonant Frequencies: (A) 250mm and (B) 215 mm PT slabs

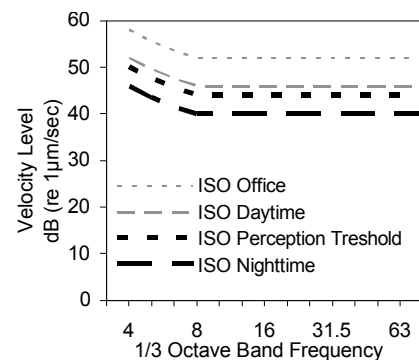
Figure 4, Vibration Criteria (re: ISO)

Vibration levels that are perceptible in office and residential spaces due to intermittent transient disturbances are undesirable, because they may startle or annoy occupants. Velocity level criteria derived from ISO 2631 are commonly used for floor vibration analysis and design.^{4,5,6} Results for the Garage 1 office development were compared with “Office” and “Daytime” perception levels. Residential floor results in Garages 2 and 3 were compared to “Perception Threshold” and “Night” criteria.

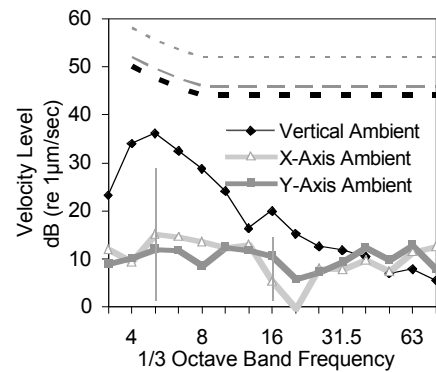
Figure 5 – 3-axis Vibration Comparison

The existing Garage 1 parking structure rises four stories above ground level. Vertical and horizontal vibration comparison shows that ambient vibration is below perception level in all directions. Vehicle pass vibration raises the vertical vibration level on the existing driveway slab well above ISO “perception threshold” and “office” criteria, but similar deck excitation above the girder beam results in much lower vibration amplitude. Prominent disturbance frequencies are in the 5 and 16 Hz 1/3 octaves.

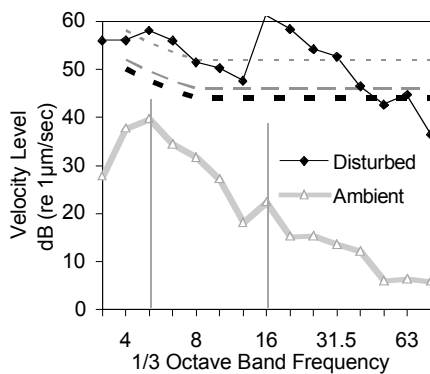
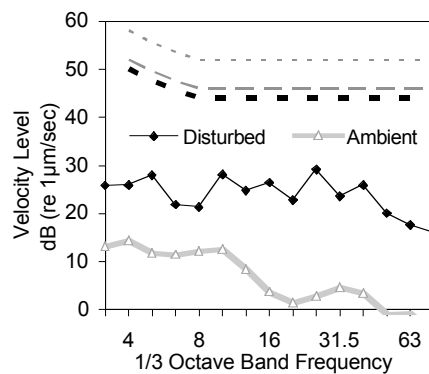
Figure 6, A & B – Ambient vs. Vehicle Pass: (A) Tee-beam Deck and (B) Deck above Girder

The proposed expansion was intended to be a steel beam and composite concrete deck with girder and beam configuration mirroring the existing girder and tee-beam garage layout. A resonant frequency above 5 Hz was recommended for the proposed office floor above the garage to de-tune the proposed office floor from the 2.5 Hz garage resonant frequency and prominent 5 Hz harmonic. The structural engineer was unable to achieve a feasible design with resonant frequency any greater than 3 Hz, due to the long span. A design revision was recommended with girder and beam directions reversed for the office structure, i.e. girders on long dimension and beams on short dimension. This resulted in a more economic structural design than the original proposal and achieved a design resonant frequency of 4 Hz for the office floor, with first harmonic of 8 Hz, which is non-coincident with the garage deck.

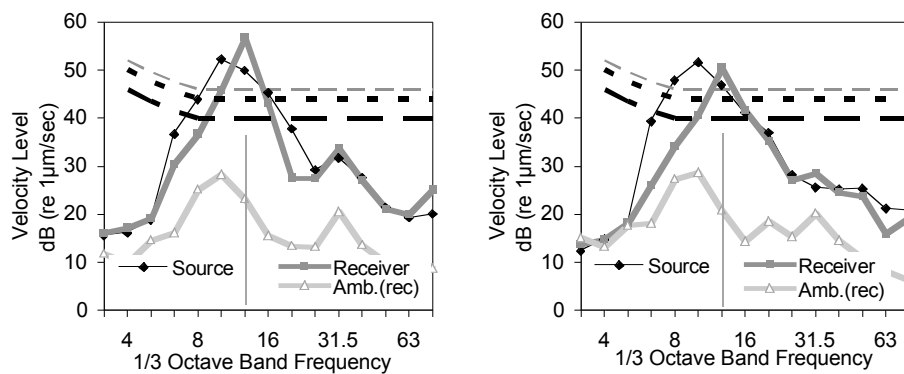
Figure 7, A & B – Ambient + Vehicle Pass on parking (receiver) vs. driveway (source):
(A) undamped slab and (B) slab with masonry damping on column line

The structural engineer and architect considered using decoupled finish floor slabs in the residential units to isolate vibration. A test was arranged to construct mock-up decoupled slabs with varying thicknesses of finish slab and of resilient underlayment media. Simultaneous measurements were made on the driveway and on the receiver floor areas to determine and compare losses. Two areas with no decoupled slab, one damped with concrete masonry units (CMU) on the column line to simulate a demising wall and one with no damping were measured. Both had disturbance vibration levels above “perception threshold” level at resonant frequency.

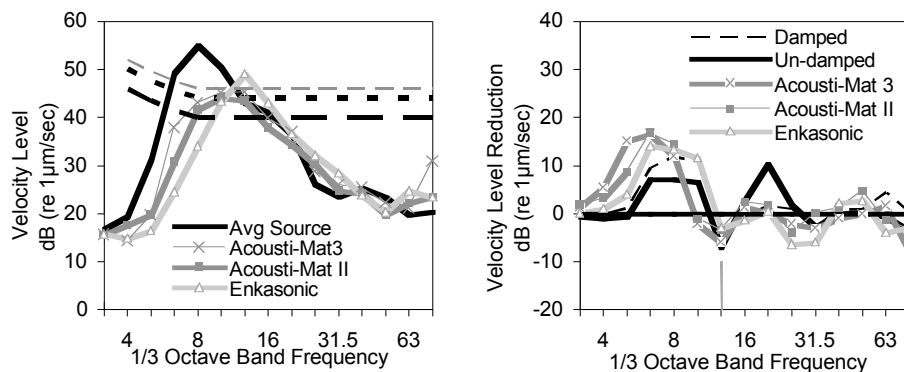
Figure 8, A & B – Vehicle Pass Vibration: (A) Level on de-coupled topping slabs and (B) Reduction on de-coupled slabs. Note negative reduction at slab resonant frequency.

Similar measurements on the de-coupled slabs also resulted in large amplitudes at the structural slab resonant frequency, although somewhat lower (below). A chart of vibration reduction (difference between source and receiver velocity levels) shows that the de-coupling provided negative loss (or amplification) at the slab resonant frequency, possibly due to inadequate damping.

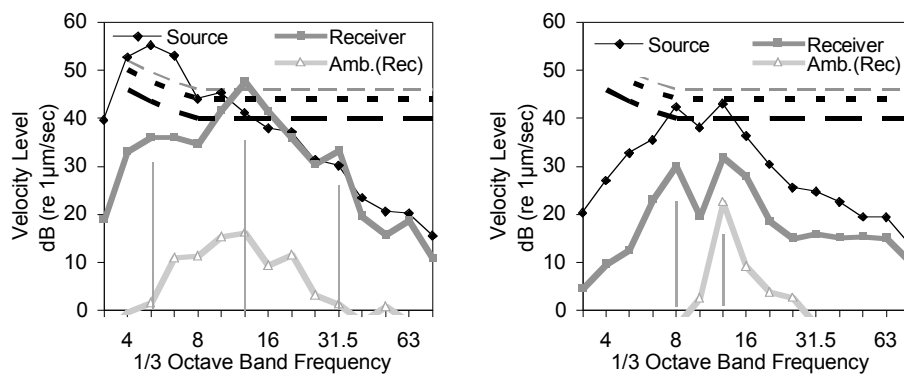
Figure 9, A & B – Ambient + Vehicle Pass on parking bay (receiver) vs. driveway (source): (A) undamped 250mm slab adjacent to drive and (B) damped 215 mm slab 1 bay from drive

The thicker-slab east end vehicle-pass floor disturbance from exceeds “perception threshold” but the thinner west end slab is only marginally touching the criterion. Both slabs have similar reinforcing and stiffness. Since resonant frequency is proportional to the square root of stiffness divided by mass,⁷ the deeper, more massive slab has somewhat lower resonant frequency and greater amplitude. The thinner west end is also farther from the source; allowing greater transmission losses.

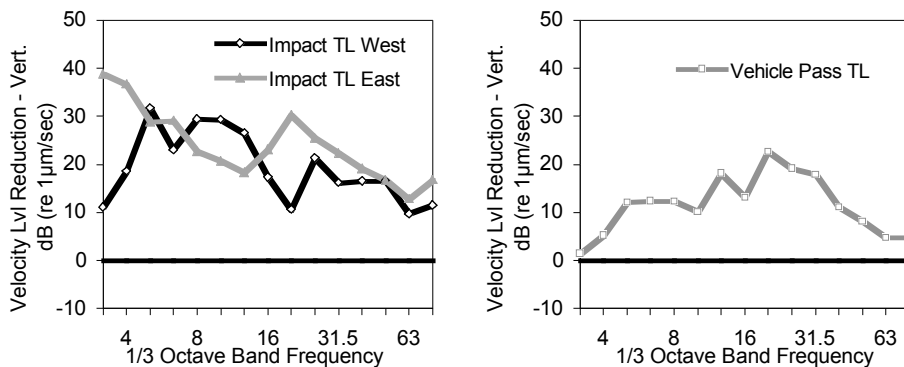
Figure 10, A & B – Vertical vibration transmission losses via columns to floor slab above: (A) Impact sources and (B) Vehicle pass on adjacent driveway bay.

Simultaneous measurements on garage level residential floor bays and identical locations on the structural slab above show vertical vibration reduction (via columns). Even at structural resonant frequencies, vibration reduction exceeded 10 dB; enough to assure that vehicle pass vibration would not cause perceptible disturbance levels on the floor level above the garage.
